The Accident in Bhopal: Observations 20 Years Later

Prepared for Presentation at
American Institute of Chemical Engineers
2006 Spring National Meeting
40th Annual Loss Prevention Symposium
Orlando, Florida
April 24-26, 2006

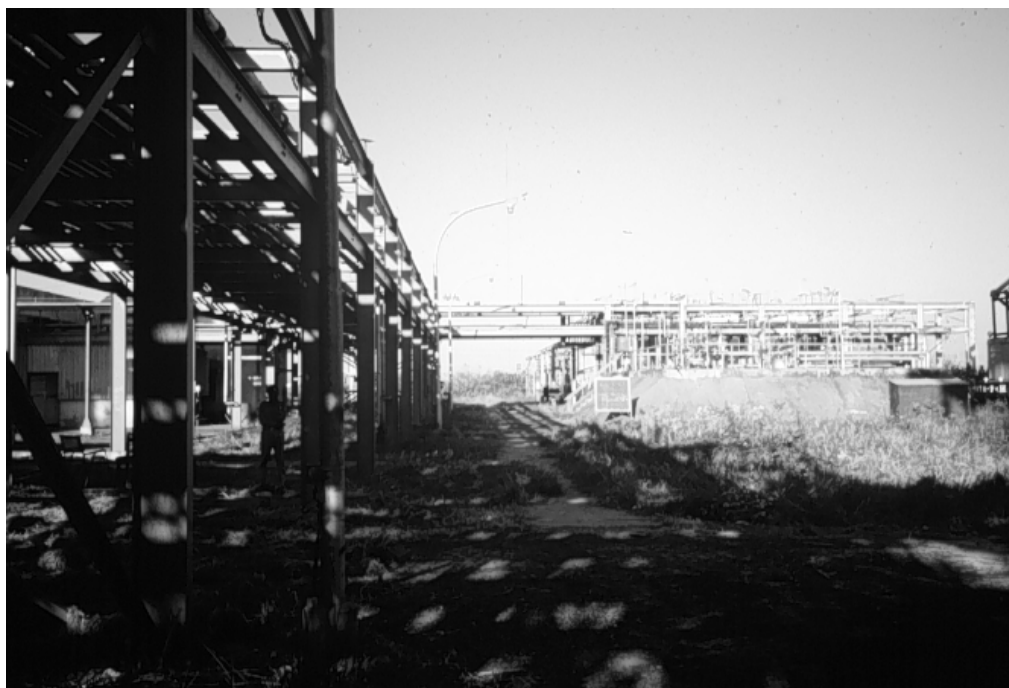
Fig. 3. Photograph taken shortly after the accident. A pipe rack is shown on the left and the partially buried storage tanks (three total) for MIC are located mid photo right.

Shown in Fig. 3, Fig. 4, and Fig. 5, are engineering details related to the storage of MIC at the Bhopal plant. The plant was “backwards” integrated from a formulation plant to a fully integrated chemical plant in the late 1970’s. Fig. 3 is a photograph looking North where the 3 MIC storage tanks were surrounded with earth for insulation (on the right side, or towards the East side of the plant layout). Fig. 4 shows a cross section of the storage tanks with piping provided for internal cooling, MIC flow in and out, and attachment to the process vent system via a relief valve should the tanks be overpressurized. Finally, Fig. 5 shows the effluent treatment system downstream of the relief valves, for treatment of any material that might be discharged if the relief valve opened, either due to overpressurization of an MIC tank or because of a relief valve leak.

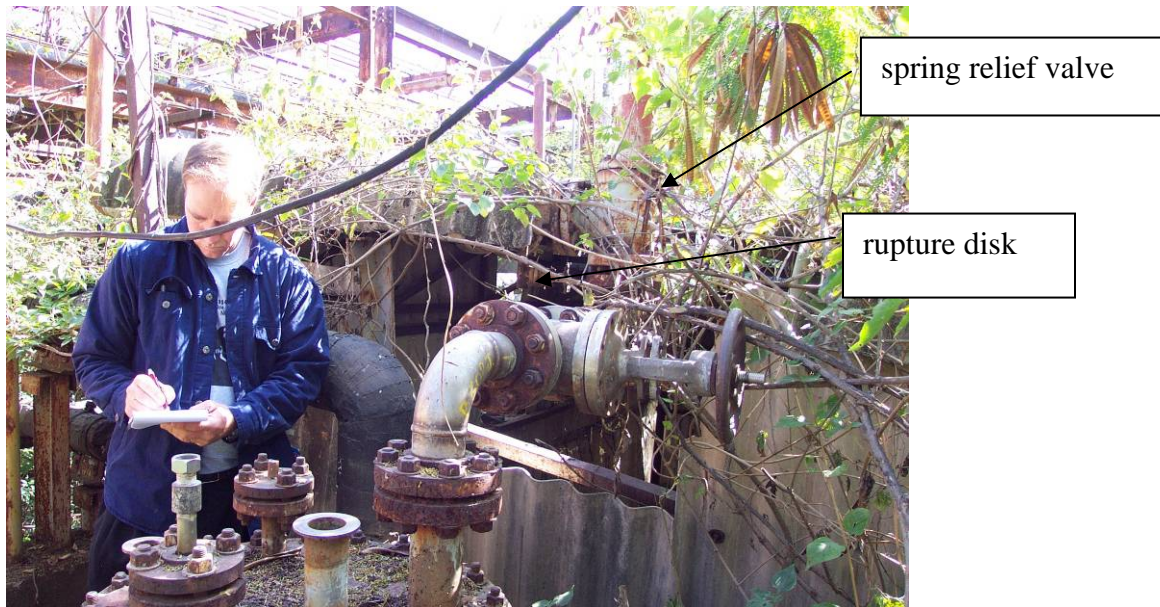
Fig. 9. Photograph of Tank 611 entry piping. Rupture disk is in center, spring relief valve is behind flora that has grown in over the years.

Our most astonishing discovery was the current condition of the Bhopal plant site. As one approaches, it looks like a jungle. Plants and trees have taken over (Fig. 6). Tank 610, the tank that over pressured and released the MIC, was removed from its underground vault, and is now above ground and totally surrounded by brush and overgrowth. Even more astonishing, sadly, bags of chemicals have been left behind, as shown in Figure 7. For 20 years! Fig. 8. is a photograph very near the filter area where a water washing cycle was underway the night of the accident. We were able to identify the gate valve that fed the process vent header located above in the pipe rack. Its stem indicated full closure, although this provides no evidence of its condition more than 20 years earlier during the incident. Fig. 9 is a photograph of the top entry to the concrete vault containing Tank 611, an identical storage tank to 610. Much of the piping is in place, undisturbed after 20 years. The rupture disk tag is still readable, and somewhat hidden, the spring relief valve that leads to the relief vent system lines. In studying the piping up close, we conclude that it is quite sophisticated. If sabotage was committed, the person who did it had to have intimate knowledge of piping into and out of the tank. Further, they had to have identified exactly how to remove a pressure indicator, and attached a quick disconnect hose connection, then after the event remove this quick disconnect hose connection (the condition it was reported to have been found by an eye witness). Fig. 10 shows the scrubber system. Manufactured of stainless steel, it is in reasonably good condition after more than 20 years. This plant had state-of-the-art equipment in place. Some motors appear as if they could operate today; simply flip the switch. Pumps, however, do show signs of corrosion after sitting in the elements for 20 years. Fig. 11 is a photograph of the flare system. This flare system went out

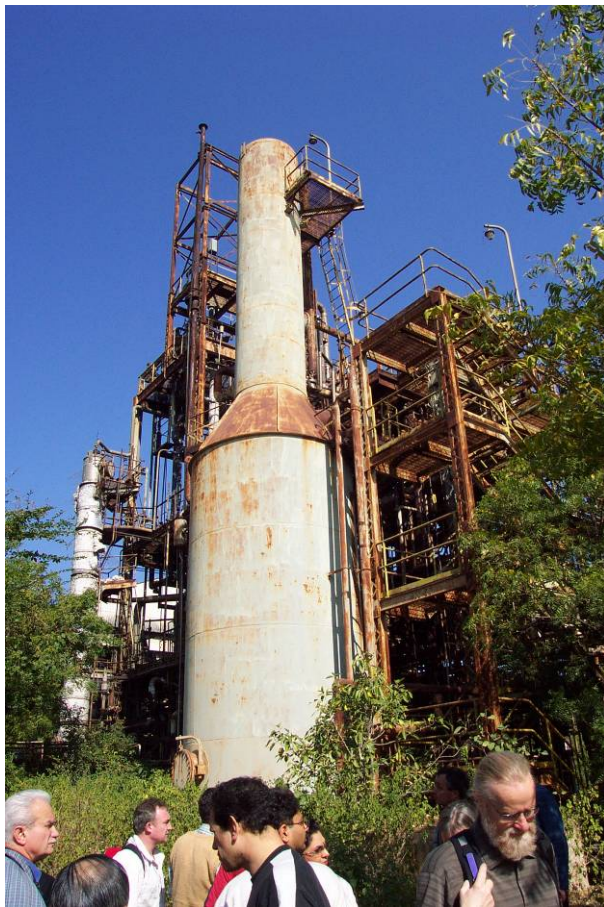
Fig. 10. Photograph of the scrubber system.

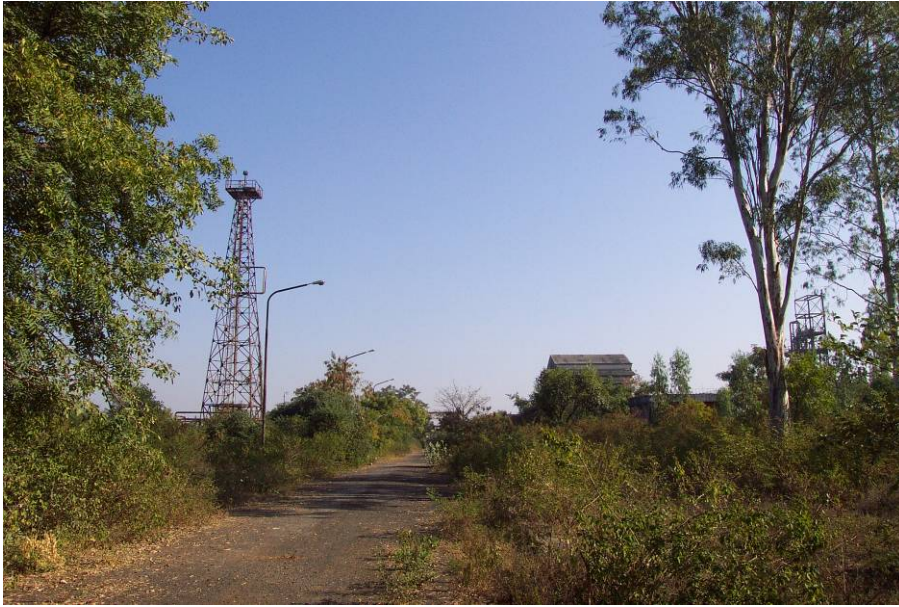
Fig. 11. Photograph of the disabled flare tower.

service several weeks earlier due to a corroded pipe replacement project [14]. Little priority was placed on repairing it because the plant at the time was not manufacturing MIC. Fig. 12 shows the control room. By early 1980's standards, this was a typical control room with state-of-the-art equipment. Much of the paper that litters the floor are the remains of operating instructions and safe work permits. Its location from the plant was about 100 m to the West, well isolated from the process area. Fig. 13 made a sobering tour somber. We heard complaints from the local engineers who served as our hosts that mercury was contaminating the ground. Initially, we thought this was an exaggeration. Regrettably, as Fig. 13 shows, mercury droplets are quite prevalent near certain units. Fig. 14 shows a tank that has corroded completely, unknown contents lying below on the ground. Disturbing.

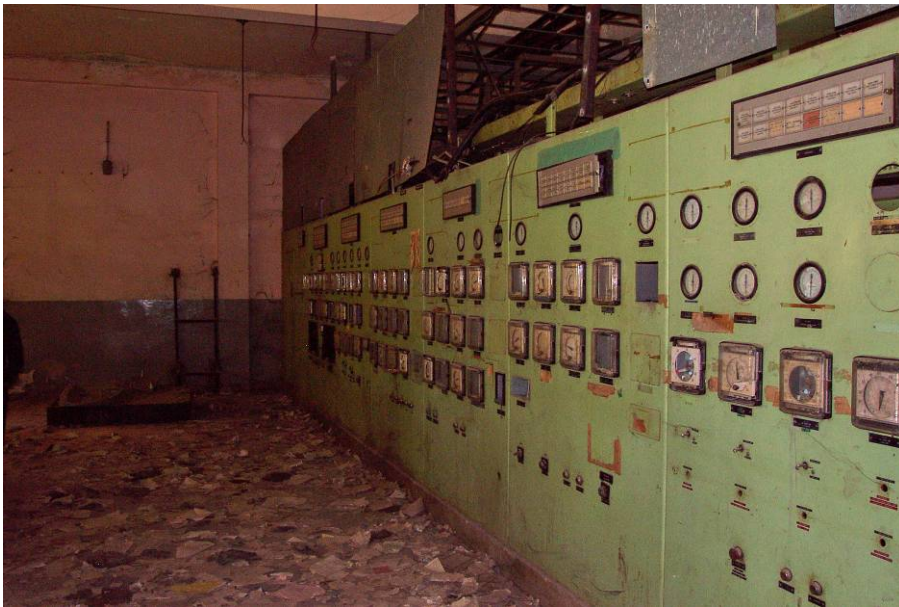
Fig. 12. Photograph of the control room 20 years later.

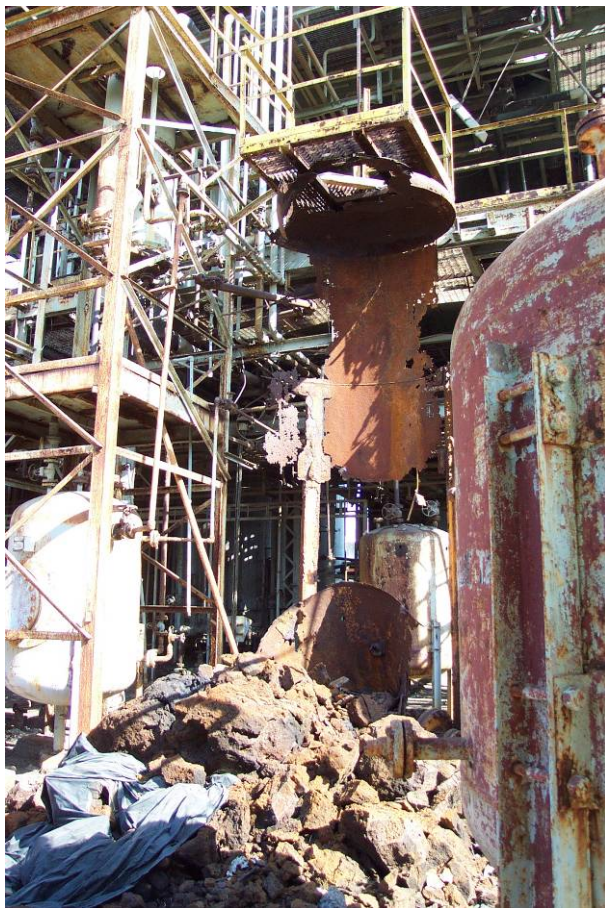
Fig. 14. Corroded tank with unknown contents lying below.
